## REHABILITATION AND UPGRADING OF A SMALL HYDROPOWER PLANT IN THE AUSTRIAN ALPS

**P. Macher<sup>1</sup>**

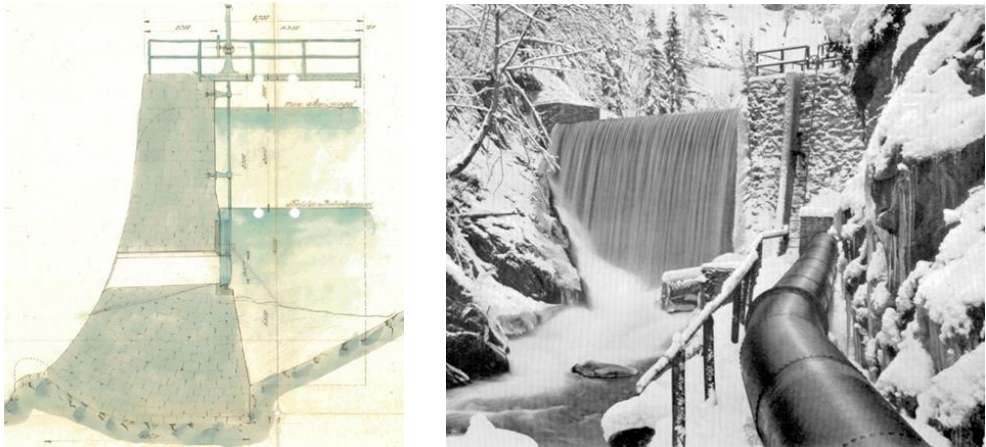
**Fig. 1. Weir and water intake of the old HPP Untertweg (foto © RHI AG)**

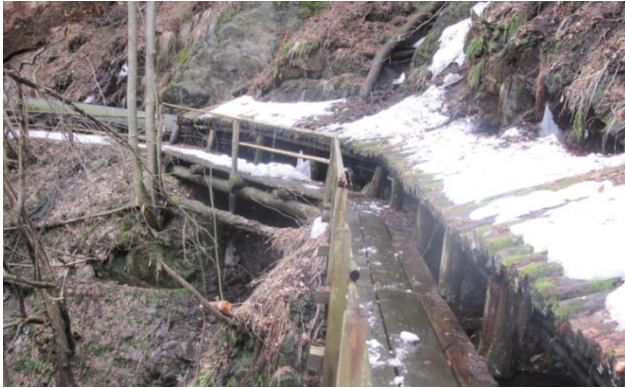
The ravages of time, especially corrosion of the riveted steel penstock and increasing silting-up of the headpond, required a major overhaul of the plant. Also, rockfall posed a threat to the safe operation of the penstock, which was only partially covered by wood logs. The silting up of the reservoir was a consequence of increasing constraints, regarding the flushing of the weir, in recent years. Not only a public lido, just next to the water mouth at 7 km downstream Millstättersee, but also an ambitious fish-breeding project, on the lower course of

**Fig. 2. Steel penstock protected by logs from rock-fall**

It was then decided to replace the whole penstock and build a new from GFRP, backfilled with reinforced soil. The decision to use GFRP pipes with not fully restraint couplings also for the 38° steep headrace before the powerhouse was backed by the experience from a recently completed project where similarly connected cast iron pipes were used. The disassembly of the existing penstock, however, remained a problem, due to the limited accessibility, and was foreseen to transport the pipes off by helicopter. For the new penstock only short pipes with limited diameter would have to be used. Due to the comparatively low weight of GFRP pipes they can also be transported with small machinery.

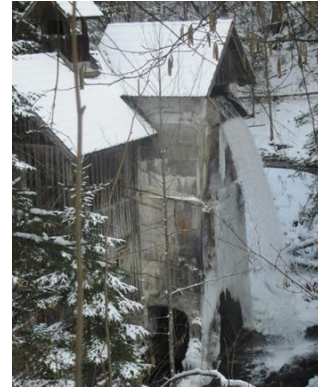
As this small private power plant was also in no good condition, an agreement was found to compensate the former owners for its closing down. This way, the head of the new powerplant was increased by 22 m. By using the existing intake and connecting directly to the

**Fig. 3. Former SHPP Obertweng**

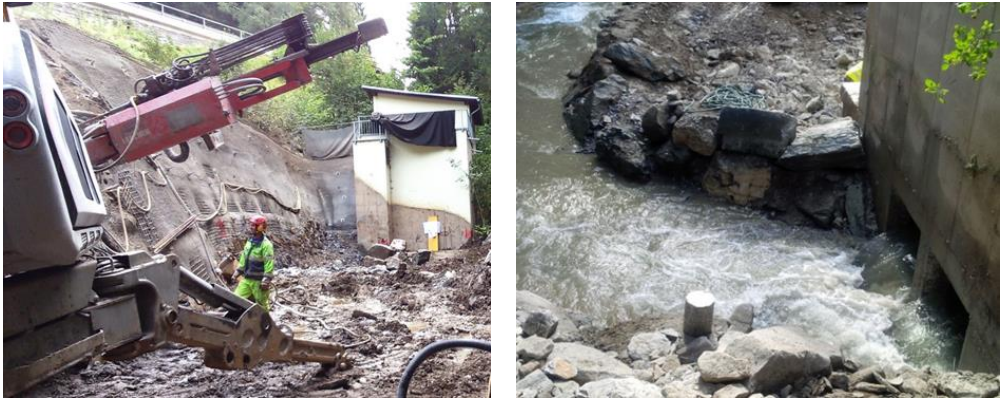
The powerhouse of the upstream Tieferbach power plant is situated very much next to the river on a steep slope below a federal road. The collecting tank for the new Untertweng power plant had to be built attached to it. The 10 m high slope support for the construction pit, made from reinforced shotcrete and rockbolts, was finished just before a major precipitation

event. Although the whole slope would be backfilled in the end and the executed securing works were thus of only temporary purpose, this event proved the necessity of the structure.

In order to minimize the standstill time of the Tieferbach powerplant, a temporary tailrace opening was cast into the powerhouse side wall.

**Fig. 4. Slope support and temporary outflow during construction time**

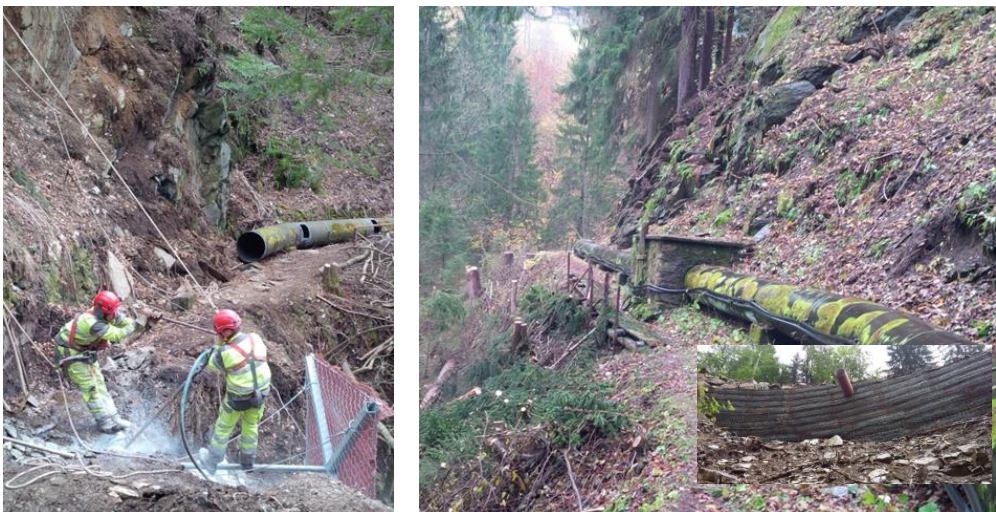
**Fig. 7. Penstock before / while dismantling; installation of slope support system; reinforced earth at access road**

The solution found was an umbrella-like slope support system that can be backfilled and loaded just after the anchor grout had hardened. The system consists of a metal cross holding a wire net-cum-geotextile that is secured in place by a rock anchor. For this particular application segments of 2.5 m x 2.0 m were used. Due to the difficult terrain, anchors had to be drilled in by hand. As the system has a finite service life time it was clear from the beginning that the purpose would be limited to the building up of the access road. The penstock had to be placed into the slope on solid rock so that it would not be affected by possible long time settlements of the backfilled access road.

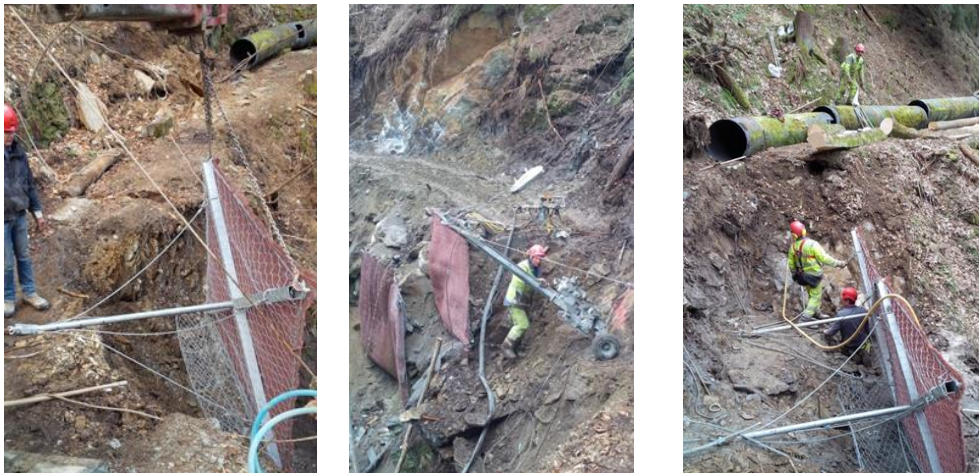
**Fig. 8. Installation of slope support system**

Lesson learned: The first support elements were initially fixed to a rock nail and secured to the rock anchor with a steel wire. As this wire was loose, a settlement of few centimeters would occur when the rock nail corrodes and the load is transferred to the rock anchor. This installation technique is appropriate for avalanche protection and protective hydraulic engineering but has to be adapted where settlements matter.

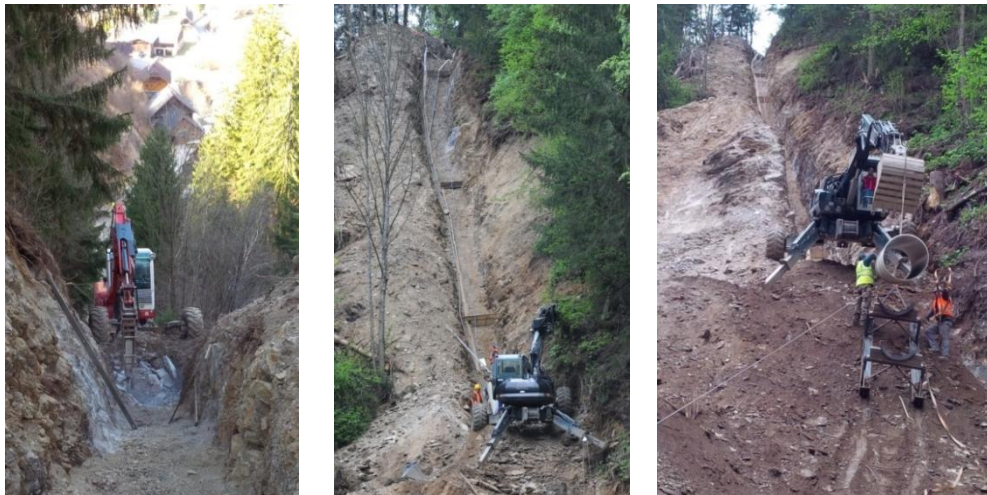
**Fig. 10. Penstock placement in the steep section before the powerhouse**

The tender design envisaged a flexibly placed penstock with cross brackets every 12 m which would fulfill majorly a sealing-up function. Due to the encountered shallow rock line, this concept was changed to placing the penstock fully embedded in concrete. Thus, the concrete also had to be transported with a sledge to the place of installation. For the concreting of the anchor block at the transition from flat to steep inclination, the concrete was pumped as the required consistence did not allow the transportation in a sledge. A special concrete mixture had to be used to be able to pump the concrete up. While the concreting itself was finished in a few hours, the mounting and demounting of the pipes on the steep incline was a matter of several days.

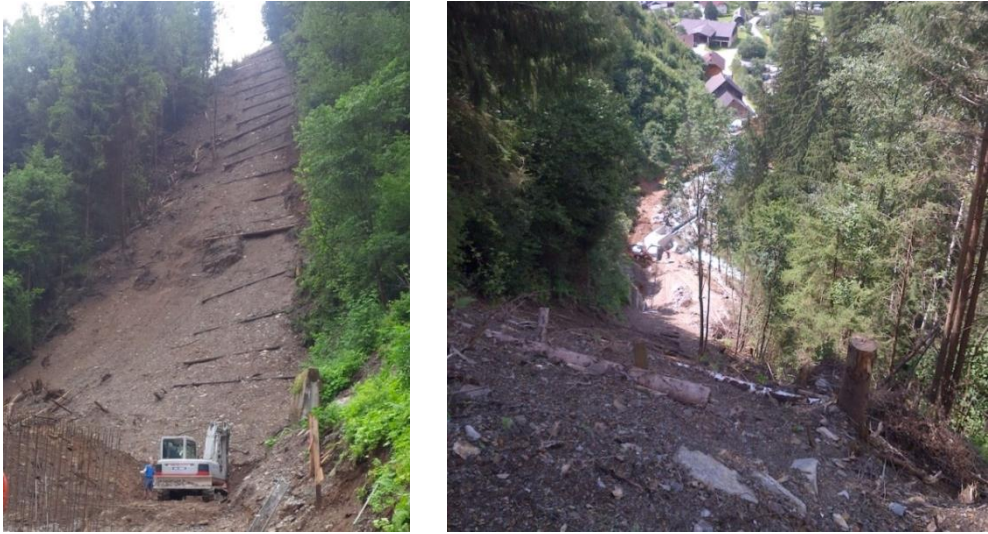
**Fig. 11. Steep slope section of the penstock before hydro seeding; hydro seeding machinery**

In order to stabilize the topsoil layer, tree trunks were placed for providing temporary stability until this function can be taken over by the vegetation. To ensure a fast growth on this steep slope, prone to washing out, hydro seeding was used.
