FORENSIC ENGINEERING

I. Vayas¹

2. Collapse of the Roof of the Archaeological Site in Santorini, Greece

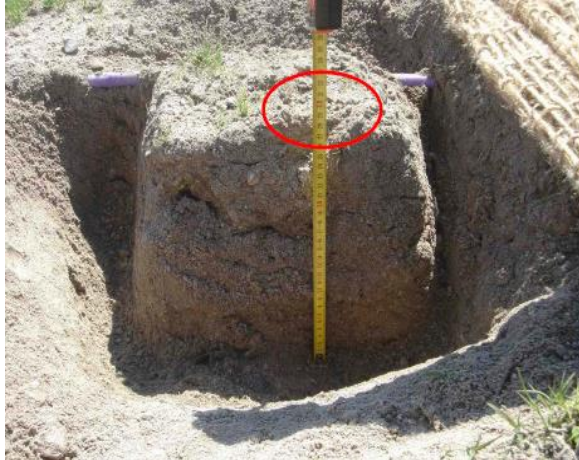
In order to investigate the case, the actual loads on the roof were determined. They were composed of the, known, self-weights of the structure and the covering panels, as well as of the self-weight of the soil that was determined by measuring its depth (Fig. 4) and its density in fully saturated conditions.

Figure 4. Measuring the depth of the soil

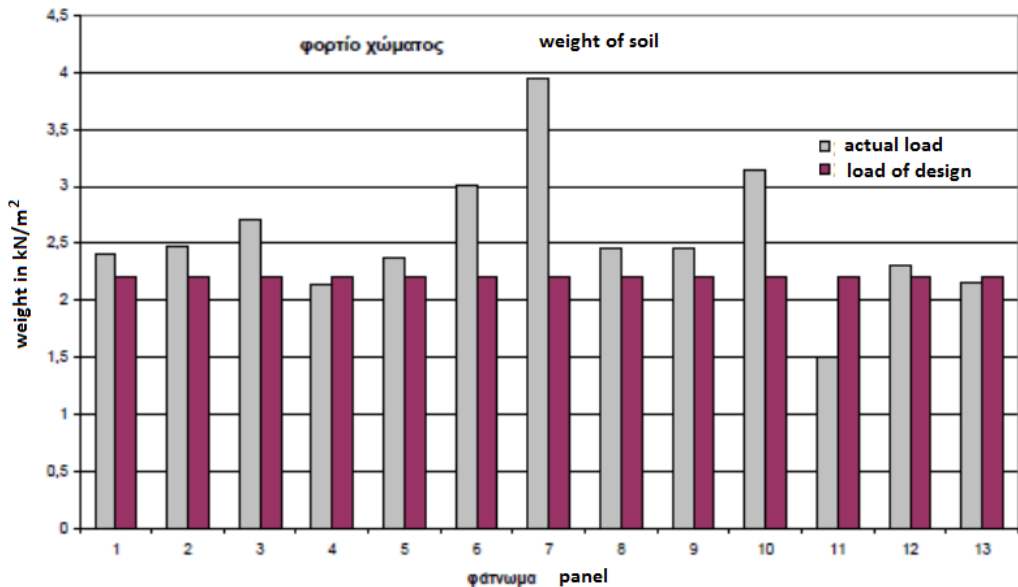
The measurements showed that the actual weight of the soil was much higher than its nominal design values, assumed in the structural design (Fig. 5). This was due to the fact that both its depth and its specific weight were much higher than those anticipated in the design phase.

Figure 5. Comparison of actual vs. assumed in design soil weight

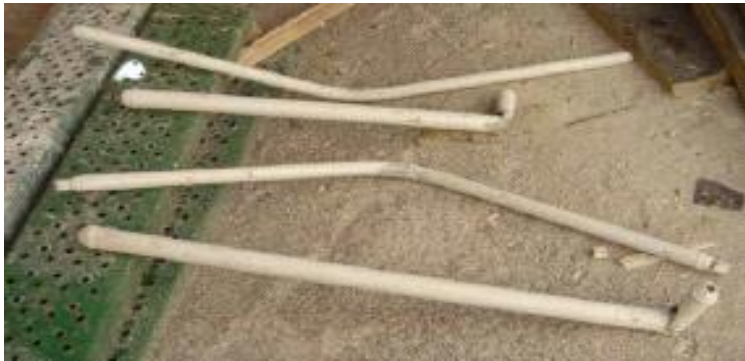
In addition, specimens were taken from bars, bolts and nodes to determine the actual material properties and to investigate the behaviour of the bars under compression and tension (Fig. 6). It was found out that the material was in accordance with the specifications assumed in the structural design.

Figure 6. Buckled bars of the structure

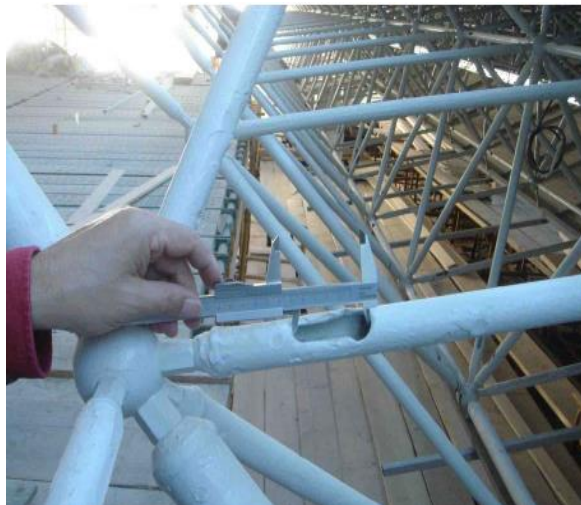
Figure 7. Bars in the actual structure (a) and their models (b)

The behaviour of bars in compression and tension has been studied numerically. The tubular bars were accurately modelled by FEM by means of shell elements in the ABAQUS software (Fig. 7). Subsequently, a geometrically and materially nonlinear analysis including imperfections (GMNIA) was performed. Numerical results compared well with the results of the experimental tests carried out in the Laboratory for both tension and compression bars (Fig. 8). Similar results were derived for compression bars.

analysis with this bar missing, safety factors below 1,0 were determined for other bars, indicating progressive collapse. This was promoted also by the fact that the bars had no ductility due to the provision of large holes opened in order to pass the connection bolts through them (Fig. 7). More information is provided in [1].

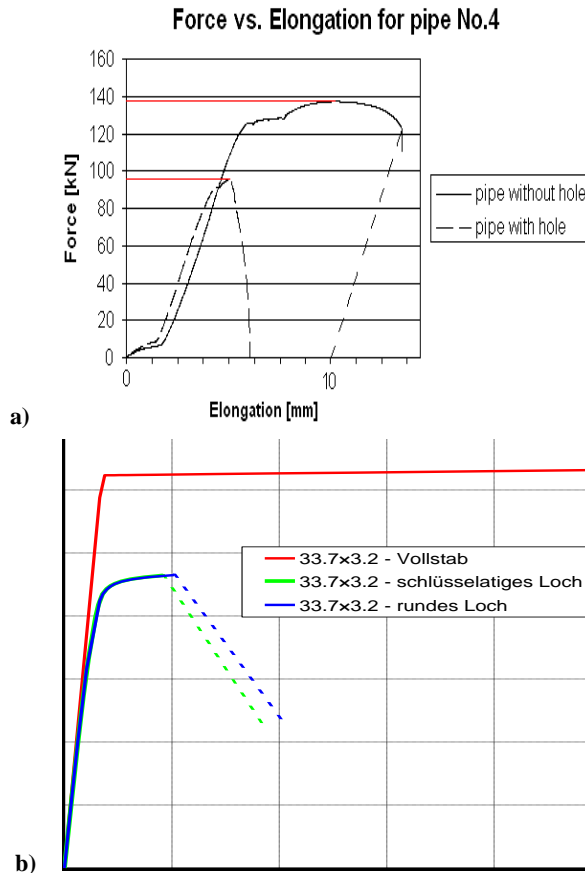
Figure 8. Experimental (a) vs. numerical results (b) for tension bars
