## STRUCTURAL STRENGTH EVALUATION BY NON-DESTRUCTIVE TESTS OF RC SLAB STRUCTURE AND ANALYSIS OF THE FAILURE CAUSES OF CONCRETE ROOF SLABS

The main objective of this paper is to evaluate the safety and serviceability of an existing structural system by Structural Strength Evaluation by Non-Destructive Tests for Reinforced concrete (RC) Slabs Structure, and Analysis of the failure causes of (RC) roof slabs.

In this paper, three cases are studied on roof slabs (two-way slab, one-way joist slab system) of three villas in Kuwait. These villas were built in 2017, 2007 and 1997, respectively.

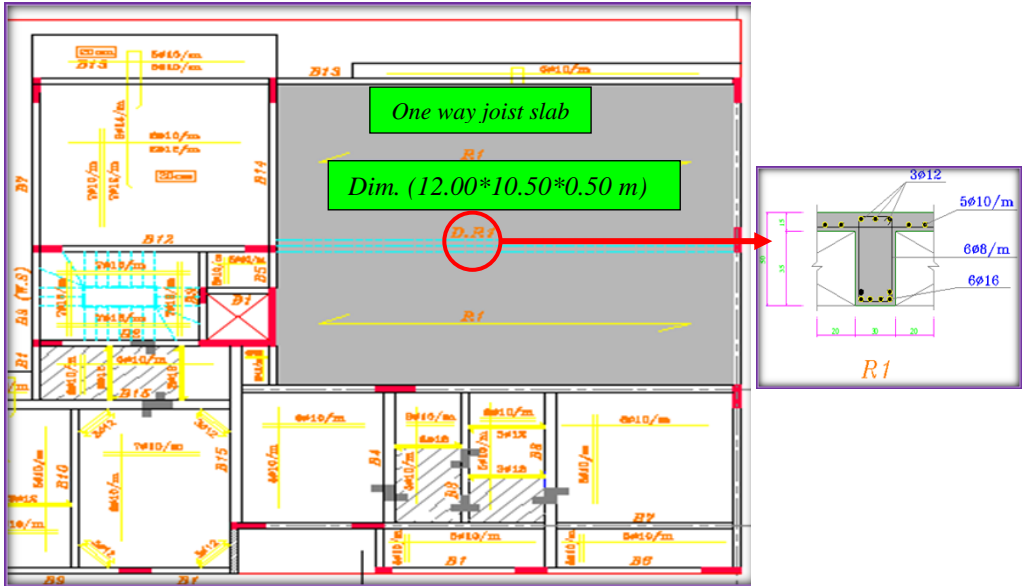
Figure 1. First and Second Floor Roof Slabs plan      Figure 2. Rib Section R1 (As Designed)

The structural geometry including columns locations and members sizes was determined from the engineering drawings attached, the slabs of the roof are two types, as we mentioned before. The second type of the slabs is one-way joist slab, the Dim. of the slab is (12.00\*10.50\*0.50 m) (*length x width x thickness*) and the section of design rib is shown in Fig. 2.

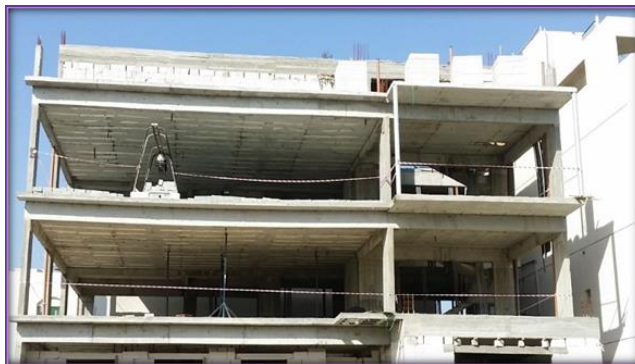
Figure 3. Elevation of building

The first case was built in Kuwait city in 2016 (Fig. 1, 2, 3) on an area of 400 m<sup>2</sup> of land, consisting of four floors: basement, ground, first and second. The building was built of Reinforced concrete (RC). The structural system consists of columns and beams and slabs. There are two types of roof slabs used in the building, the first one is solid slabs and the second is *one-way joist slab*. That is usually used for wide spaces such as halls that are performed without columns in the middle of it. In this case we will focus on two slabs of the building that have clear crack and deflection problems; the first and second floor roofs are a *one-way joist slab system RC* concrete.

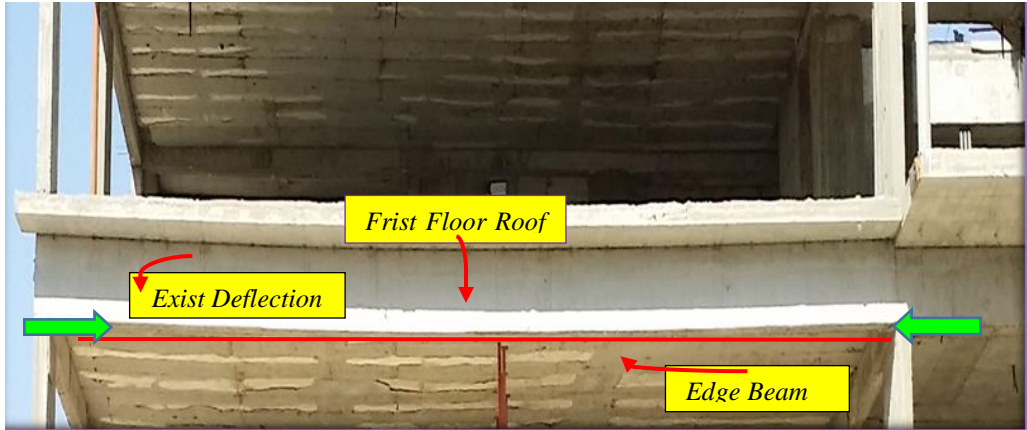
At the roof of the basement and the ground floor there was no notice of a deflection of the slab or what is alleged to worry; on the contrary, in the roof slabs of the first and second floors deflection was apparent with the naked eye in the joist and edge beam and when measured was about 6 – 7 cm in the middle of the span. Also, cracks appeared in the joists and beam in addition to the vibration of the slab, therefore it was important to check the safety of the construction of the roof, which required carrying loading test for both slabs (Fig. 4) (One-way joist system with a 12.00 m length, 0.50 m thickness, static load test).

Figure 4. Slab and edge beam with 6 – 7 cm deflection in the middle of the span

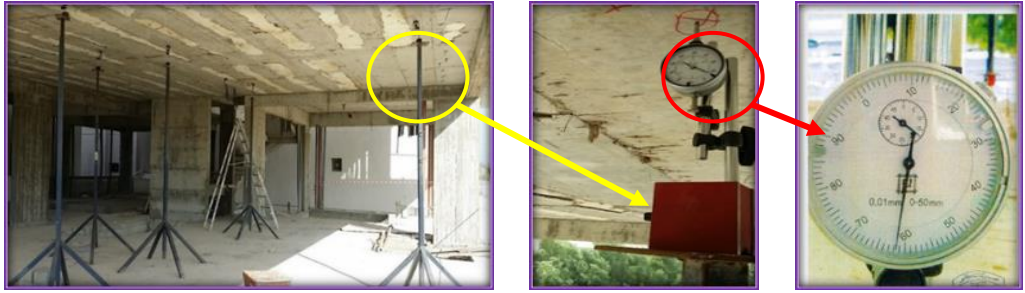
Figure 6. Dial Gauges Installation in F.F.S and Magnetic Holder

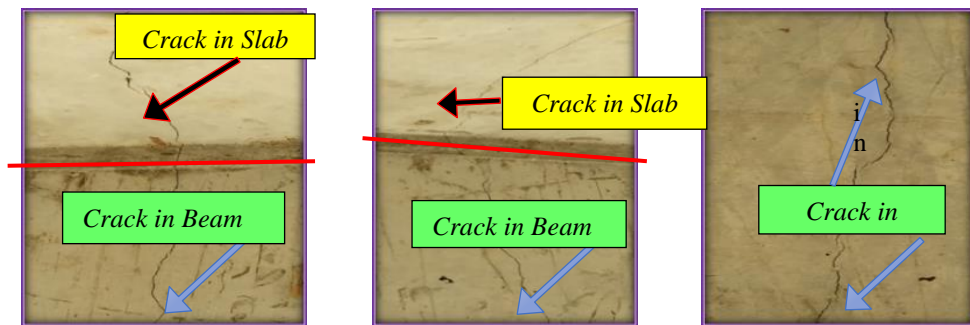
*During the 3rd stage of loading the excessive deflection was measured, cracks appeared in the slab and edge beam, it became wider for that we stopped the increase of the load (Fig. 7)*

**Figure 7. Cracks at the edge beam and F.F.S**

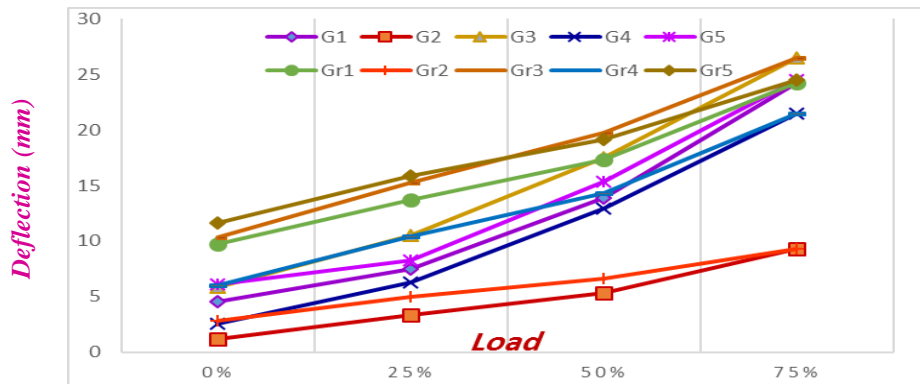
The graph in Fig. 8 shows the relationships between the maximum deflection of the slab deflection for the dial gauge No.1 (G1) is 19.72 mm and the rebound deflection is 5.20 mm. For the dial gauge No.5 (G5), the maximum slab deflection is 18.41 mm and the rebound deflection is 5.35 mm. From the load test results, all maximum deflections ( $\Delta_{max}$ ) from the testing must be less than the calculated deflection that is 11.025 mm (calculated from Equation (2)) and the rebound deflections must be less than the calculated rebound deflections that are shown in the last column of Table 2 as well.

Figure 8. Relationships between Defl.(G), Rebound Defl.(Gr) and Max. Load Percent G1-G5  
*“Structural member tested (First Floor Roof Slab) does not satisfy Criteria I or Criteria II”*

This slab has been suggested for demolition because the maximum deflection is more than the allowable as per equation (2) (11.025 mm) and also before applying all of the load as well as many cracks have appeared.

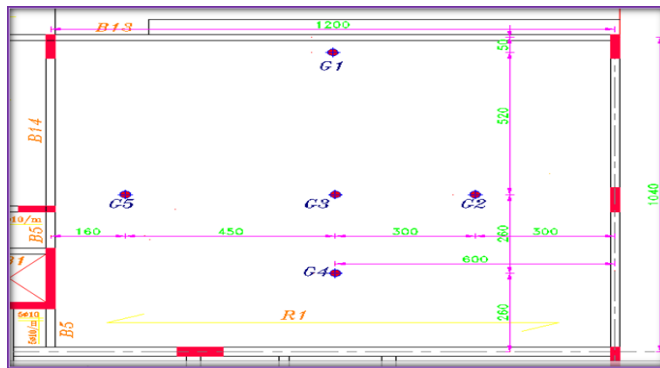
Fig. 9 is showing the location of the Dial Gauges on the plan of the second floor slab.

Figure 9. Location of the Dial Gauges on the plan of SFR

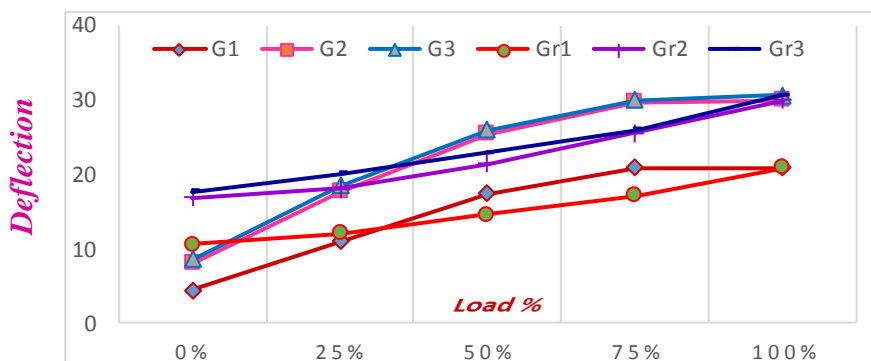
**Figure 10. Relationship between Defl. (G), Rebound Defl. (Gr) and Max. Load Percentage**

After the experimental results that appeared in the load test the slabs were unsafe, according to the first and second procedures of the ACI-318, so the Engineering Consulting Office decided to demolish and remove both slabs, roof I and roof II.

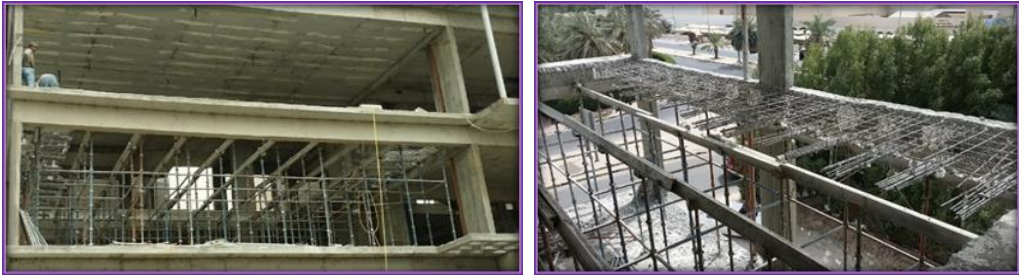
Upon completion of the demolition and removal, important things were found out:

- \* The total thickness of the executed slab ranges from 43 to 45 cm.
- \* The thickness of the slab is variable of the slab and varies from one place to other.
- \* The thickness of the concrete slab above the ribs ranges from 8 to 12 cm.
- \* The reinforcement is complying with the design which is 6 # 16 per rib.
- \* Concrete is weak in some places and positions of the slab.
- \* Distribution of ribs, molds, and interstitial spaces between ribs is irregular and unequal.

Figure 11. Reinforced concrete slabs after cutting

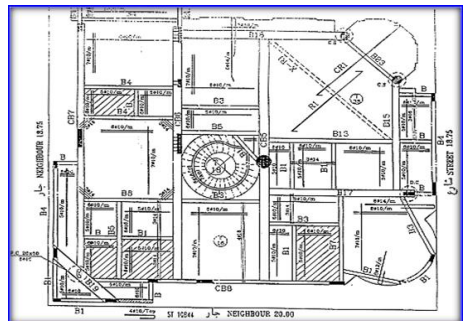
Figure 14. Ground floor roof slab

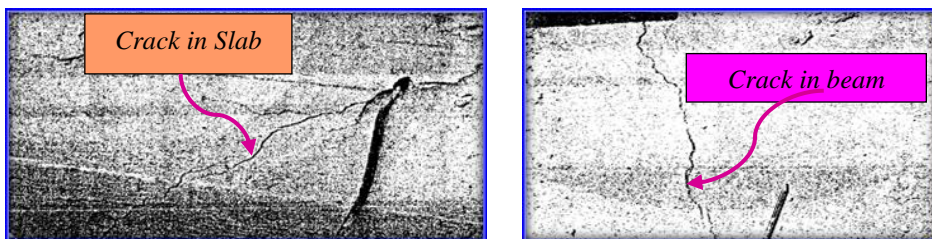
The cracks were distributed at the positive and negative moment regions. The deflection was in the center of the slabs. The testing (core test) was of slabs and beam to assess the strength of the existing concrete and look for reasons if it fails. A detailed optical inspection was carried out to identify the apparent structural defects and to compare the dimensions of the structural elements executed on the site as well as what is required by the structural design drawings for some elements of the building:

Figure 16. Cracks at the beam and slab

The study shows that the structural elements in the building need supporting and strengthening to enable the building to carry out the structural role required to ensure the structural safety required for the building. The repair process should be designed for defective structural elements by a consulting engineering firm specializing in repairs.

Beams and slabs in each landing should be repaired by a specialized company and engineering supervision.

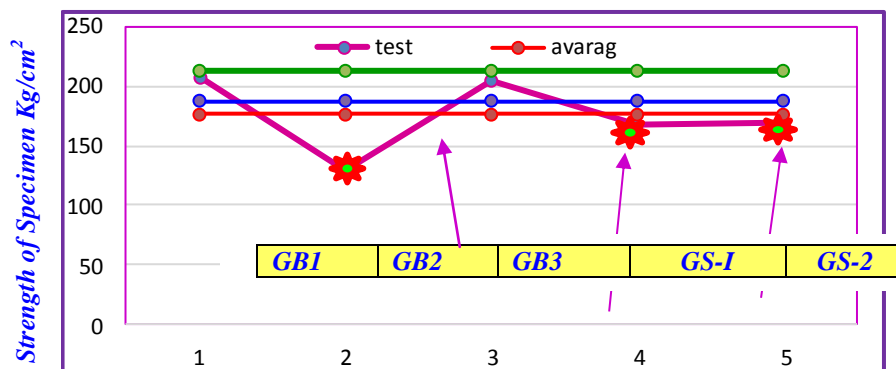
The cause of the concrete weakness was due to the design of the concrete mixture also by the company; supplying the concrete by increasing the water or due to bad curing of the concrete by the contractor company. It is necessary to verify the slabs in other ways, such as a load test (Fig. 17).

**Figure 17. Strength of core test, Average, Min., Not less**

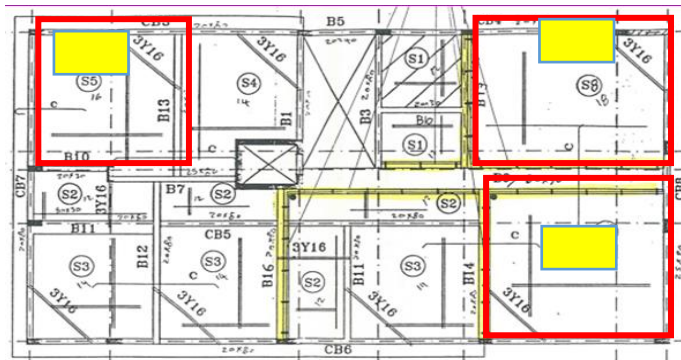
Figure 18. Ground Floor Roof Slabs plan

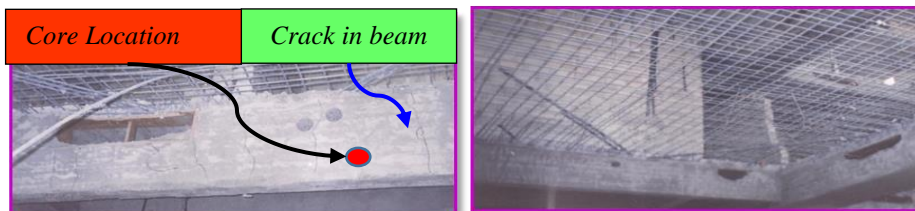
- 1 – The air conditioning openings are near to the beams support points (at the high shear points), causing fractures and cracks in these places (Fig. 19).
- 2 – The concrete cover of the steel reinforcing of the beams is insufficient as the stirrups steel reinforcing have appeared from the bottom of the beam.
- 3 – There are cracks around most of the air conditioning openings in the beams.
- 4 – Nesting and voids (honeycomb) in concrete.
- 5 – There are inclined cracks in some beams and lack of straightness (Fig. 19).
- 6 – Adhesion of the bars of steel reinforcing in the some beams, which prevents the passage of concrete, causing a lack of cohesion between concrete and steel.

Figure 19. Cracks in these beams

- 1 – Due to the weakness of the concrete and the numerous cracks in the slabs of the ground and first roof, it is broken and re-poured after proper reinforcement work and the continuity of adjacent slabs.
- 2 – Strengthening of some of the beams, identified in the site by appropriate sectors of steel with the use of the necessary epoxy materials.
- 3 – Reinforcing some columns with steel sections.
- 4 – Applying epoxy layer to the old concrete faces where they are bonded with the new concrete before casting directly [9].
