REHABILITATION OF LOCAL ARCHITECTURAL AND STRUCTURAL TECHNOLOGIES FROM THE CENTRAL BALKAN MOUNTAINS REGION AND THEIR APPLICATION IN THE PRESENT-DAY CONDITIONS

Tz. Daskalova¹

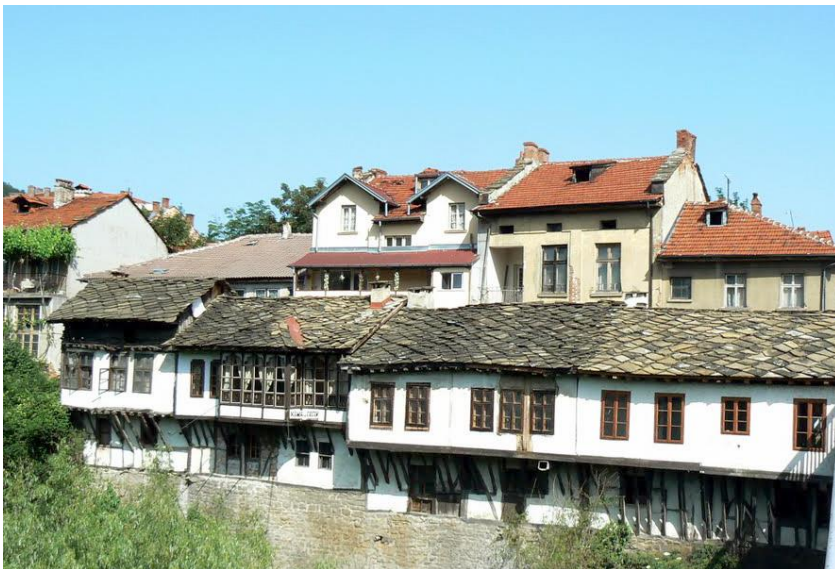
This complex of several old houses is a group cultural heritage that has preserved the look and feel of the old craft town. The buildings are interconnected, two-storeyed with artisan workshops and shops located on the ground floor, oriented to the former “craft street”, while the second level with large bay windows above the river is designated for residential purposes. The buildings are in very poor condition. Apart from the first one, closest to the bridge, which functions as a shop, the rest of the buildings are unusable and have partially destroyed roofs. The complex is private property and the access to the buildings was denied.

Figure 1. Markov Bridge House Complex, view from the bridge

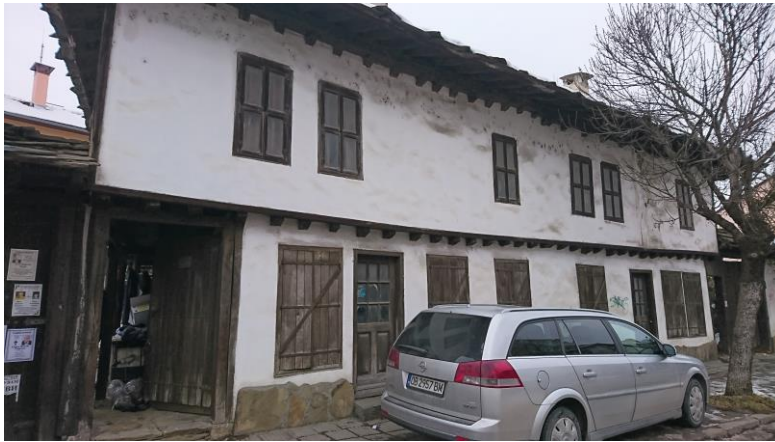
The building is currently unusable. The authentic timber frame structure is preserved, with brick filling (partially replaced by hollow bricks) and a joist floor structure. The facade is plastered with lime plaster and the windows are timber with preserved timber covers. The roof is multilayered with timber structure and the covering is preserved with stone roof tiles. Due to serious structural problems, several broken timber beams and the risk of collapse, the building was not selected for the student`s intervention.

Figure 2. Vlasi Vlaskovski house

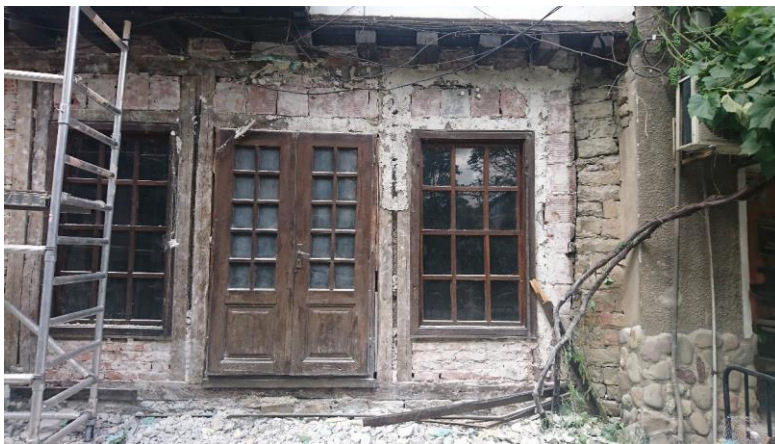
This building has been chosen as an object of intervention and restoration activities by the students, because of its characteristics and good condition. The building has been used in recent years as a restaurant. Over the years, several repairs have been made in which part of the original materials have been replaced and materials inappropriate and uncharacteristic for the Revival construction technology – expanded polystyrene and cement plasters on the facades, have been used.

Figure 3. The current state of the main facade

The building has a well-preserved timber frame structure, adobe brick walls, partly replaced with new bricks and partly stone masonry in the ground floor. The roof structure is timber, with a covering of stone roof tiles that are well preserved. In the courtyard, there is a timber staircase, leading to the vestibule, but the old railings have been replaced by new ones, alien to the original interpretation.

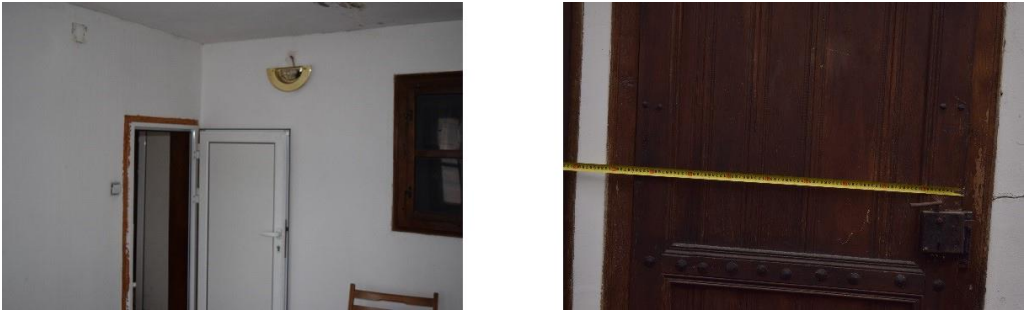
The premises have also undergone several changes and many of the interior doors, replaced with plastic or aluminium, have been irretrievably lost. The preserved original timber doors have been thoroughly measured and described.

Figure 4. The current state of the doors

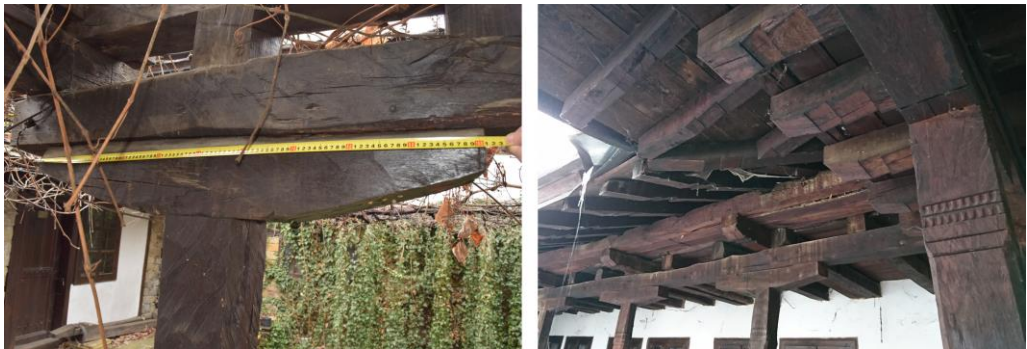
One of the most characteristic details in traditional revival house structure is the beam-column joint.

This connection between the columns and the main beams is made with an auxiliary element (pillow in Bulgarian), a short support, located below the main beam. The elements are joined by a wooden dowel assembly for greater horizontal stability.

Figure 6. The current state of the beam-column joints

Therefore, the compromised elements of the timber frame must be replaced by aged building parts from other structures. Timber joints in this type of structure have limited or no moment-resistance capacity, and as a result, they are statically indeterminate. One of the characteristics of these timber structures is that each element is independent of the others. In this way, an element belonging to a frame can be repaired or replaced without altering the structural integrity of the system.

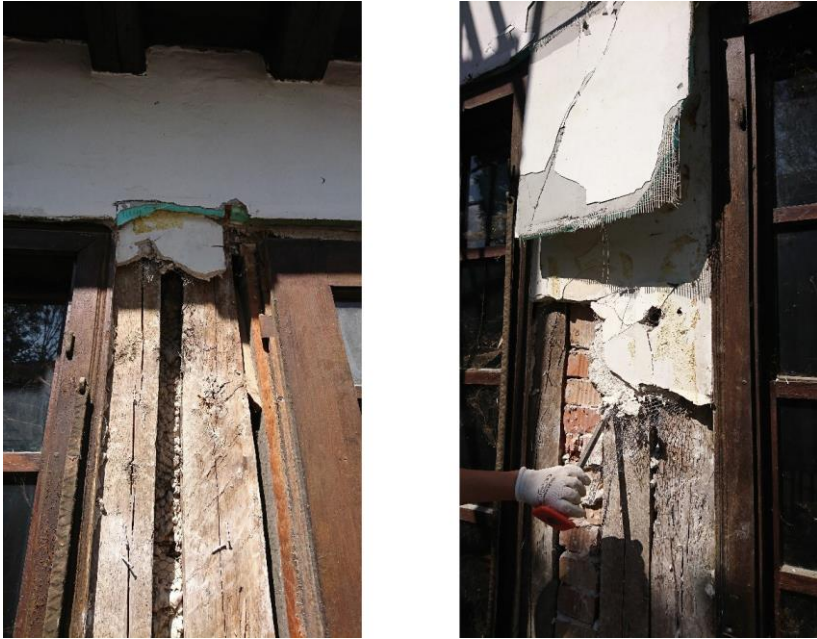
Figure 7. The current state of the timber columns

During the hands-on workshop, students, under the guidance of specialists from Röffix, rebuilt the structure of the enclosing walls and performed stone masonry restoration work on the ground level. Under the direction of a master carpenter, they repaired the compromised elements of the timber ladder and several timber horizontal beams (santrachi) in the structure of the stone masonry.

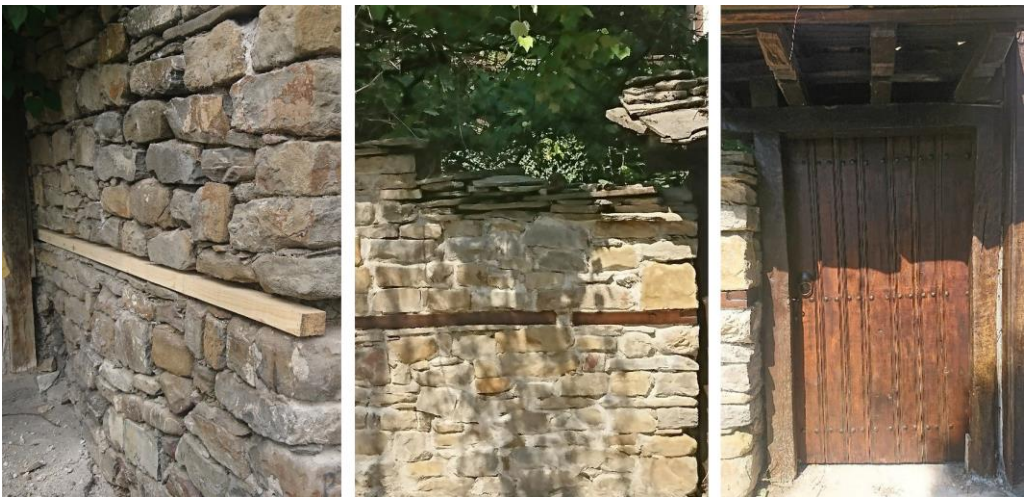
Figure 8. Work on the timber elements

The joints of the stone masonry were also repointed with hydraulic lime mortar.

All timber facade elements – windows, doors and covers were cleaned, grinded, sanded and protected with natural impregnating solutions.

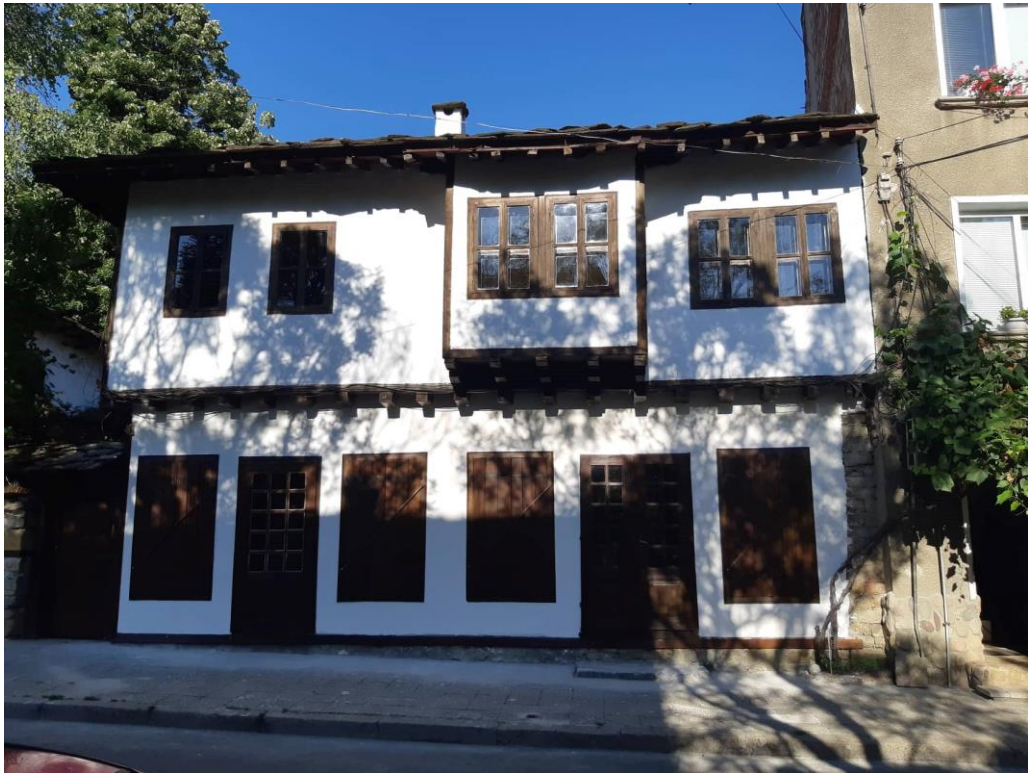
Figure 9. The main facade after the students' work

The time dedicated to practical training is not sufficient to achieve complete restoration of the building, even if only externally. In order to fully complete the process, it is envisaged to subsequently remove the vertical planed elements of the railing and to find and recycle aged boards and mats from other houses to restore its original appearance. As there is not severe pathology in the structural material despite the heavy stone roof, partial material deterioration and the cumulative effect of past earthquakes, only a few components should be replaced.
