## ENERGY EFFICIENCY OF CULTURAL HERITAGE BUILDINGS – OPPORTUNITIES AND CHALLENGES

M. Vasov<sup>1</sup>, N. Cekic<sup>2</sup>

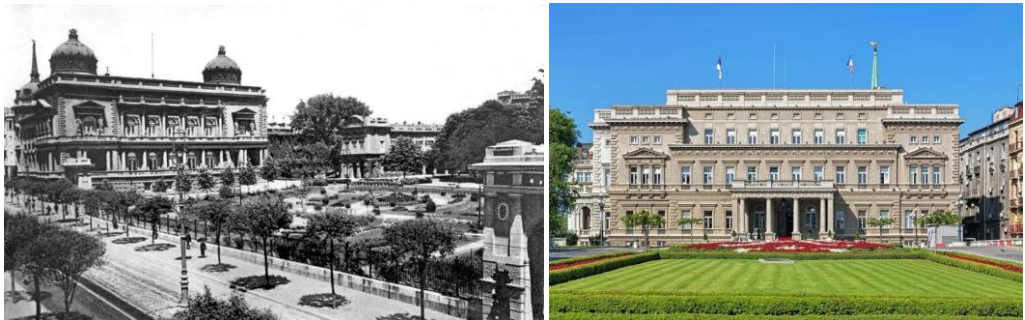
**Figure 1. Appearance of the Old Palace in the past (image left) and today (image right) [7] – Source: [https://beogradskonasledje.rs/katalog\\_kd/zgrada-starog-dvora-2](https://beogradskonasledje.rs/katalog_kd/zgrada-starog-dvora-2) [7]**

The Old Palace building (Figure 1-left) was designed by architect Aleksandar Bugarski, and since 1961 it has been the seat of the Belgrade City Assembly. Throughout its history, the building has undergone several reconstructions, mostly due to damage caused during the war. The most recent major reconstruction was undertaken in 2013 with the aim of improving the building’s energy performance (Figure 1-right) [7].

Since the building is protected as a cultural monument, all interventions had to be done in accordance with the conservation requirements defined by the Institute for the Protection of Cultural Monuments. The exterior facade of the building preserved its authentic appearance, including the facade decorations, which meant that improvements to the thermal envelope could only be implemented in non-exposed areas, such as the interior sides of attics and roofs. Additionally, hybrid facade carpentry was introduced, where the exterior frame was retained in its original form, while the interior frame was made of modern materials with double glazing.

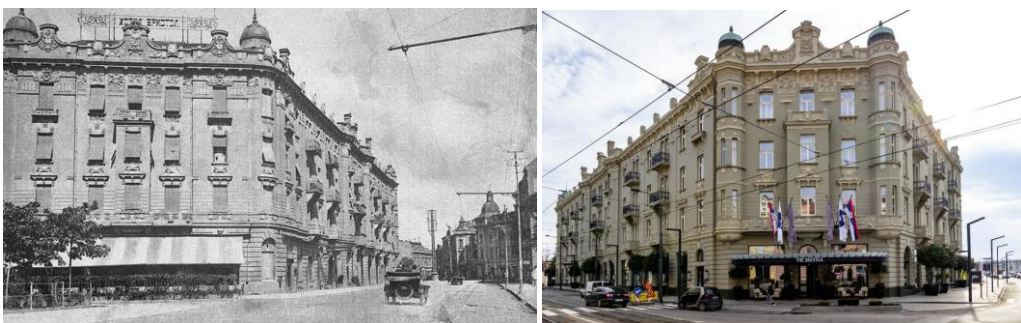
**Figure 2. Appearance of the Bristol Hotel in the past (image left) [7] and today (image right) – Source: <https://beobuild.rs/otvoren-rekonstruisan-hotel-bristol-p3216.html> [10]**

The Bristol Hotel was built between 1910 and 1912, based on a design by architect Nikola Nestorović (Figure 2-left) [7]. The building represents one of the first modern hotels in Belgrade, designed and constructed with elements and decorative motifs characteristic of the Art Nouveau style [9].

Due to the conservation restrictions, interventions on the facade facing the street of the Bristol Hotel were kept to a minimum (Figure 8-right). Accordingly, the energy upgrade of the building focused on the elements of the thermal envelope: facade walls, transparent surfaces, sloped and flat roofs, and the floors above and ceilings below unheated spaces. The walls were

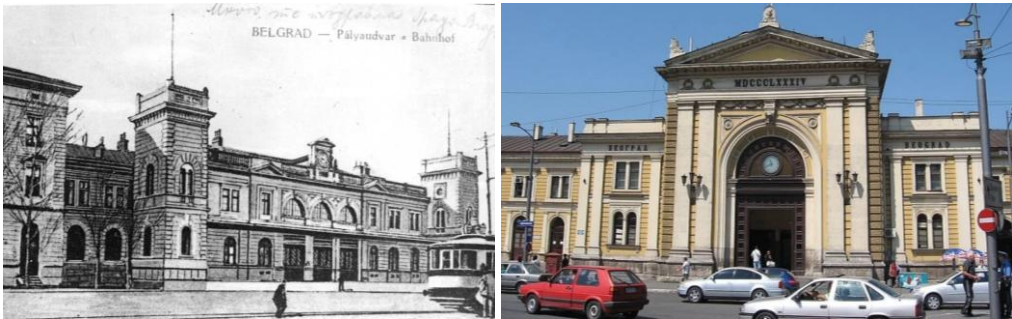
Figure 3. Appearance of the Belgrade Railway Station in the past (image left) [9] and today (image right) – Source: [https://beogradskonasledje.rs/katalog\\_kd/zeleznicka-stanica](https://beogradskonasledje.rs/katalog_kd/zeleznicka-stanica) [7]

The Belgrade Railway Station is one of the most representative examples of public architecture from the second half of the 19<sup>th</sup> century in Serbia (Figure 3-left) [7]. According to the Cultural Heritage Protection Act, the building is registered as a cultural monument of great importance, officially recognizing its cultural and architectural significance (“Official Gazette of SRS”, No. 28/83).

The project was designed by architects Wilhelm von Flattich and von Schlicht, while the technical solution was worked out by engineer Dragutin Dragiša Milutinović. The building was constructed in the spirit of classical architectural language, characteristic of European railway architecture of that era. Its architecture reflects a synthesis of stylistic and contemporary technological trends, blending elements of Neo-Renaissance, Neo-Baroque, and other styles (Figure 3-right) [9].
