## REHABILITATION AND UPGRADING OF A SMALL HYDROPOWER PLANT IN THE AUSTRIAN ALPS

**P. Macher<sup>1</sup>**

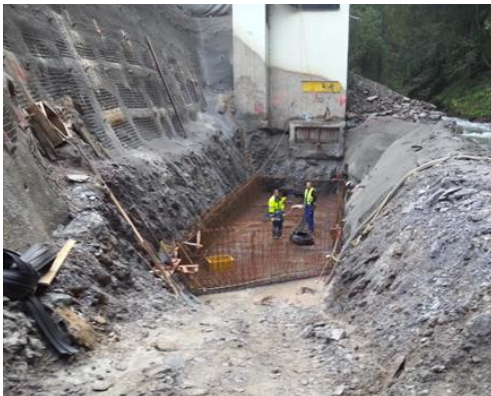
**Fig. 5. Collecting tank bottom plate**

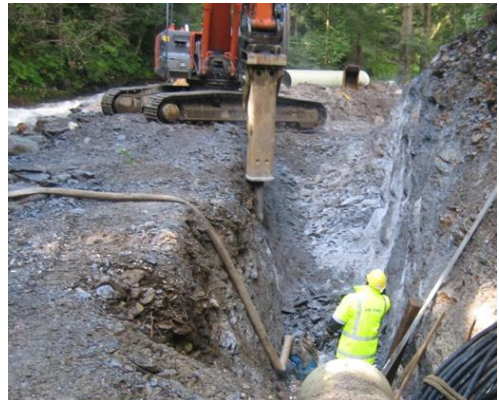
**Fig. 6. Penstock placing in the river bed**

The part of the penstock executed in 2014 had to be built in the river bed and had to cross the river with a duct about 100 m before the old head pond. Construction was stopped

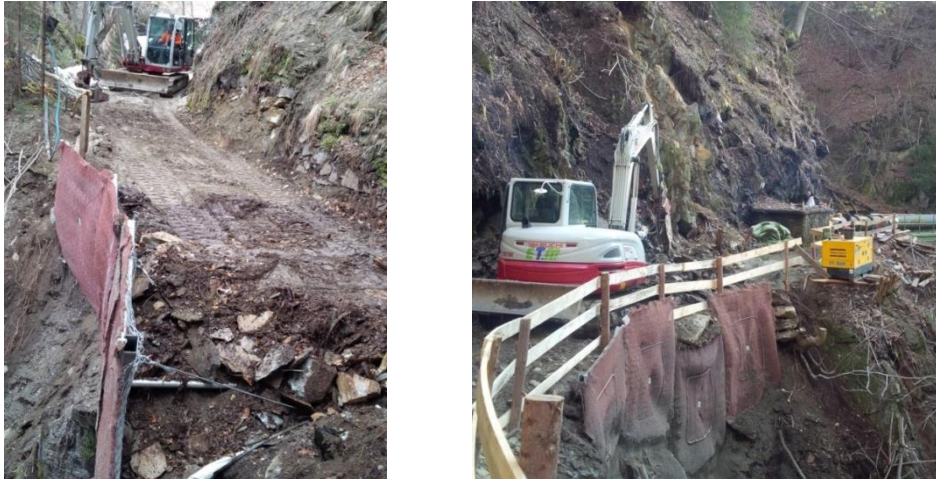
The solution found was an umbrella-like slope support system that can be backfilled and loaded just after the anchor grout had hardened. The system consists of a metal cross holding a wire net-cum-geotextile that is secured in place by a rock anchor. For this particular application segments of 2.5 m x 2.0 m were used. Due to the difficult terrain, anchors had to be drilled in by hand. As the system has a finite service life time it was clear from the beginning that the purpose would be limited to the building up of the access road. The penstock had to be placed into the slope on solid rock so that it would not be affected by possible long time settlements of the backfilled access road.

**Fig. 9. Access road on top of slope support**

Lesson learned: The first support elements were initially fixed to a rock nail and secured to the rock anchor with a steel wire. As this wire was loose, a settlement of few centimeters would occur when the rock nail corrodes and the load is transferred to the rock anchor. This installation technique is appropriate for avalanche protection and protective hydraulic engineering but has to be adapted where settlements matter.
